LAKE MUSCONETCONG

NJ 00328

PHASE 1 INSPECTION REPORT
NATIONAL DAM SAFETY PROGRAM

Philadelphia District
Corps of Engineers
Philadelphia, Pennsylvania

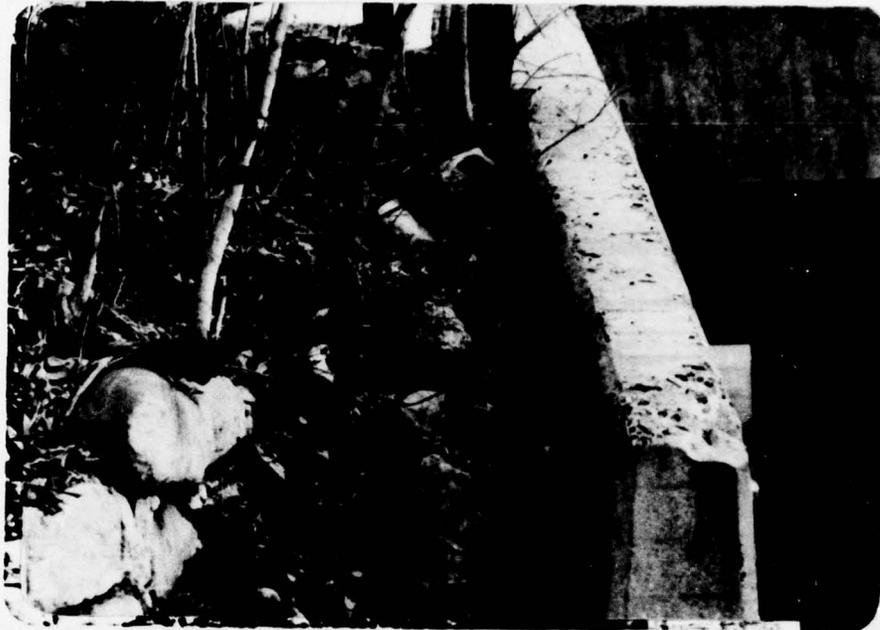
Erosion and spalled concrete 7 December 1978
at right sidewall below culvert
under Route 206.

5. Spalled and eroded areas on the downstream face of the spillway, the sidewalls, the discharge outlet structure, and the upstream end of the culvert under Route 206 should be repaired. This should be done in the near future.

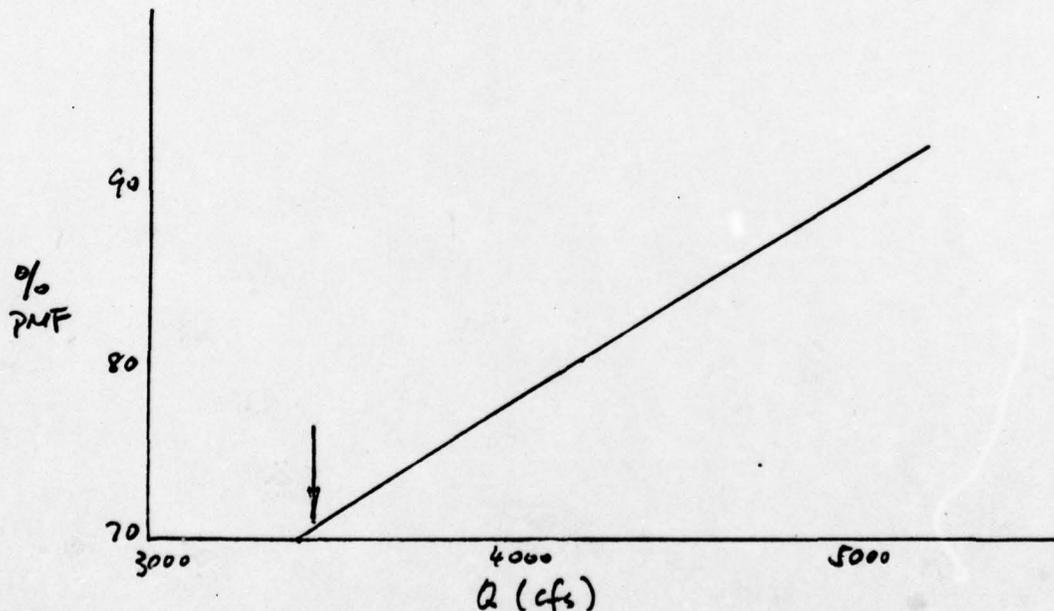
OVERTOPPING POTENTIAL

3. Dam overtops at approx. El. 863.5 with $Q = 3460$ cfs.
∴ dam can pass approx. 71% of PMF.
